PRE-DEMOLITION ASBESTOS SURVEY REPORT

NEELYTOWN BEAVER DAM MONTGOMERY
459, 475, 483, 497 Beaver Dam Road and
355 Neelytown
Montgomery, NY 12549

July 25, 2022
Partner Project No. 22-374308.2

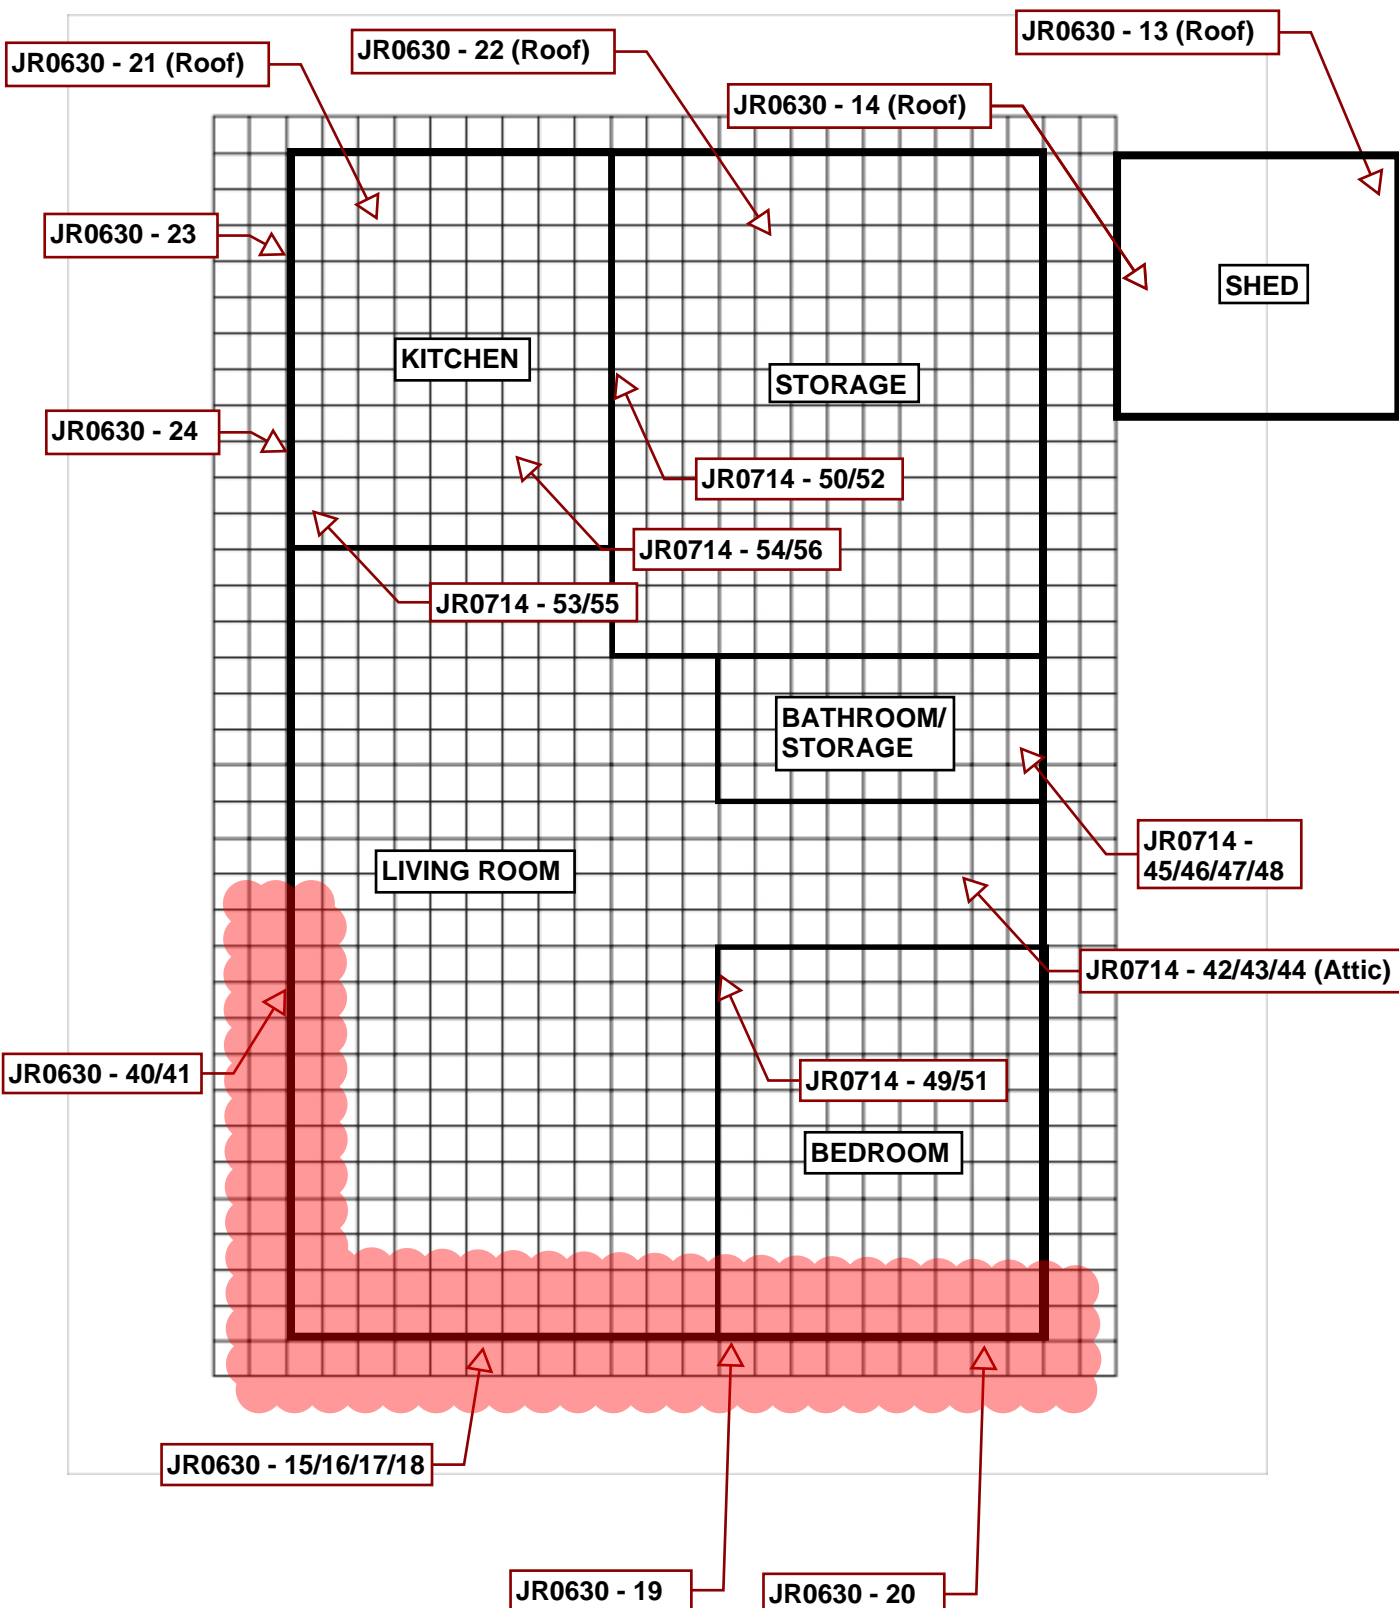
ASBESTOS AND BULK SAMPLE LOCATION DRAWING
 459 BEAVER DAM ROAD
 MONTGOMERY, NY 12549
 PARTNER PROJECT NO. 22-374308.2
 SCALE: NOT TO SCALE
 DATE: JULY 23, 2022

- Exterior Transite Shingles – Approximately 750 SF

= APPROXIMATELY 750 SF OF
 TRANSITE SHINGLES

- 3) **459 Beaver Dam Road – Transite Shingles:** This non-friable material at the subject property was noted to be in good condition. This material must be abated prior to demolition.

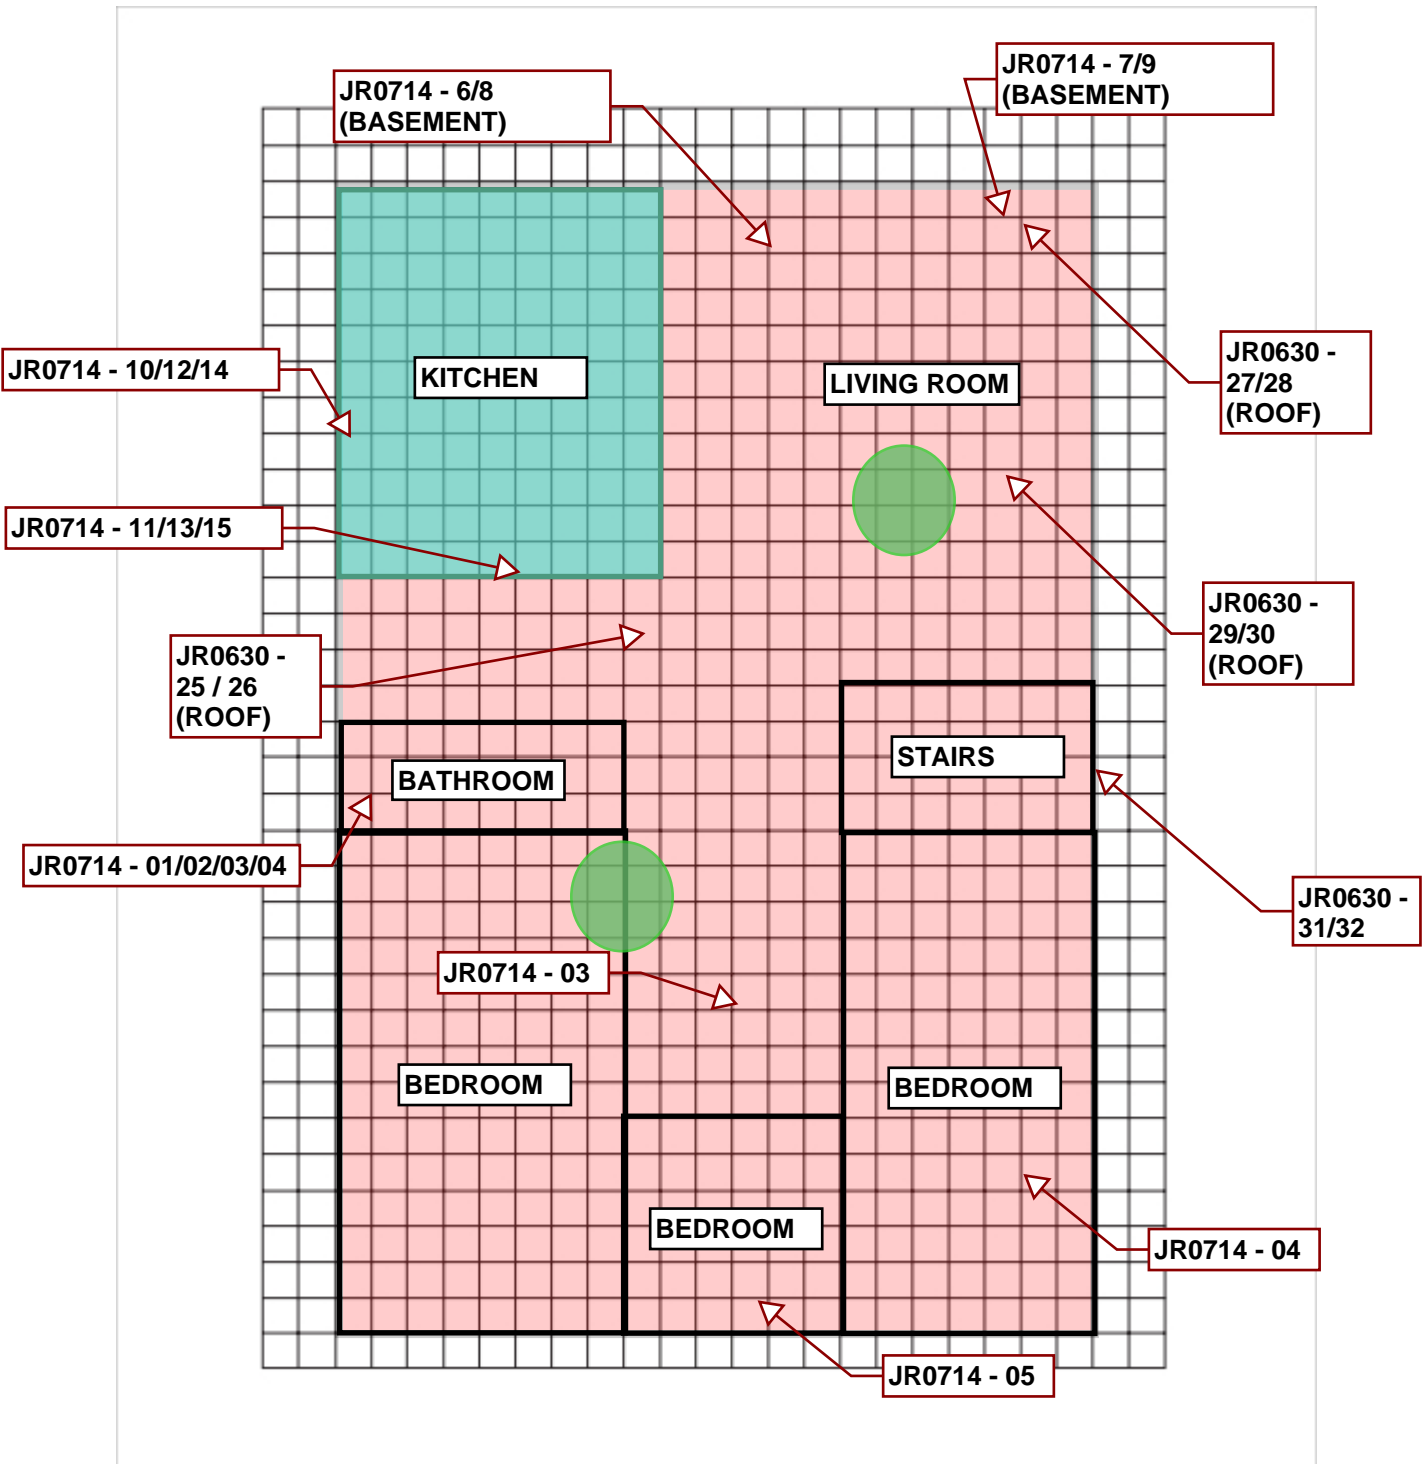
ALL WALLBOARD/ JOINT COMPOUND MUST BE CONSIDERED ASBESTOS CONTAINING 5,000 SF

- 1) **475 Beaver Dam Road - Joint Compound:** The associated gypsum board is also considered an ACM because it cannot be reasonably separated from the joint compound. This material was observed throughout the residence; therefore, all of the walls and ceilings must be considered ACM. This material is not considered to be friable when in good, in-tact, condition. The joint compound is encapsulated by layers of paint. This material must be abated prior to demolition.

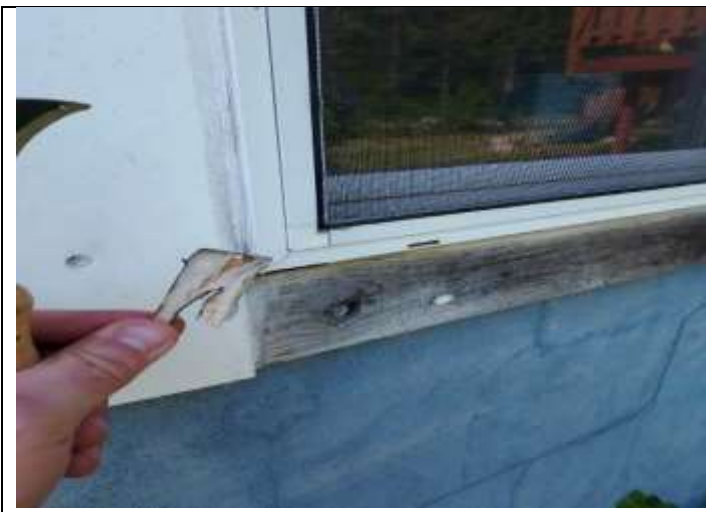
3. View of 355 Neelytown Road - Exterior Window Caulking

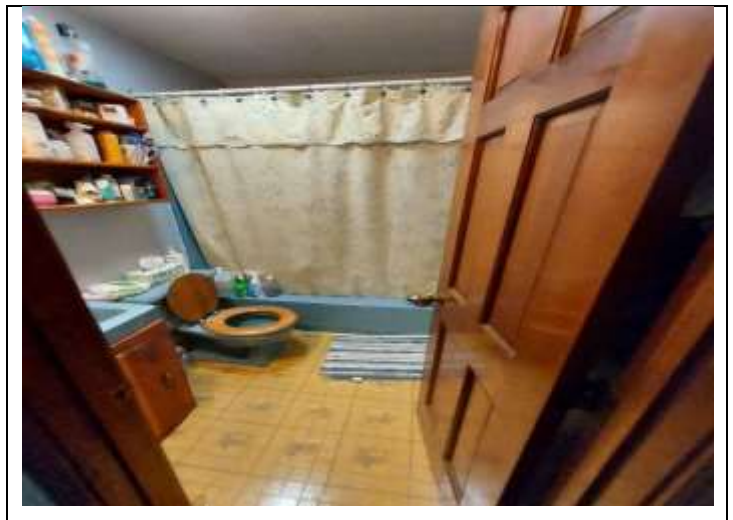
- Kitchen Linoleum - Approximately 50 SF
- Bathroom Linoleum - Approximately 20 SF

6. View of 355 Neelytown Road - Bathroom ACM Linoleum

- 2) **475 Beaver Dam Road, 355 Neelytown Road - Floor Tile, Chimney and Vent Flashing at Roof:** These non-friable materials at the subject properties were noted to be in good condition, and/or encapsulated by additional flooring. These materials must be abated prior to demolition.

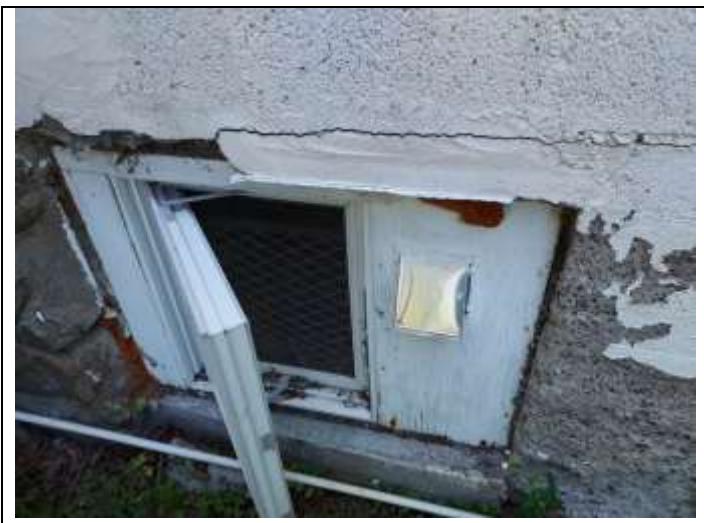
21. View of 497 Beaver Dam Road – Ext. Window Caulking

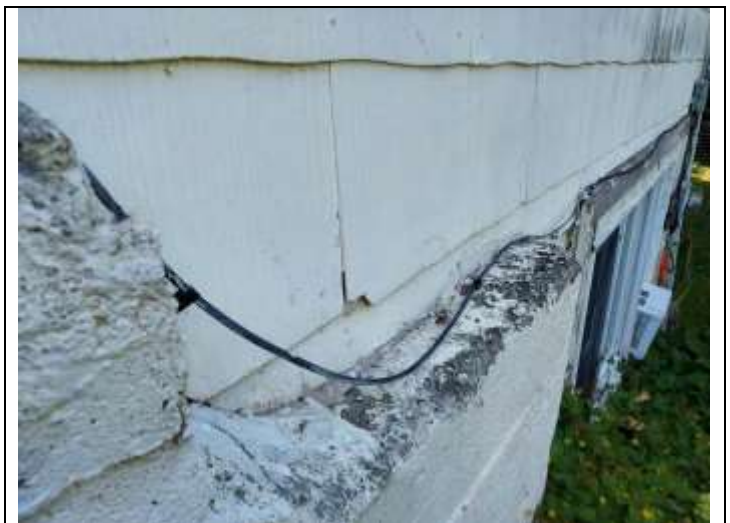
22. View of 497 Beaver Dam Road – ACM Transite Shingles

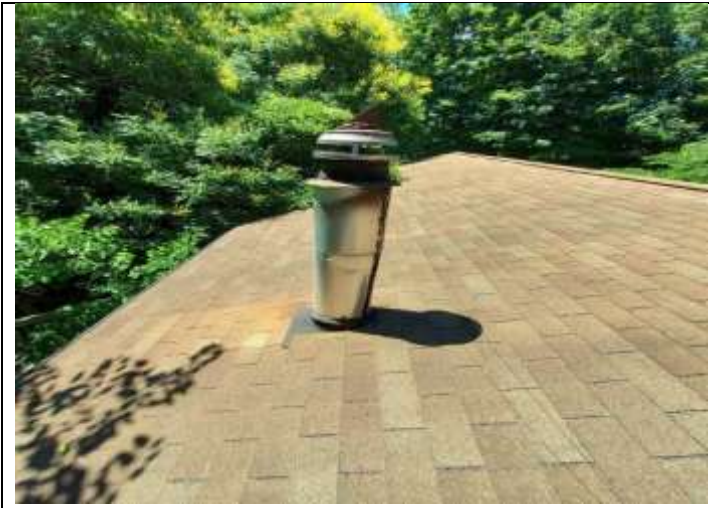
33. View of 475 Beaver Dam Road – ACM Vent Flashing

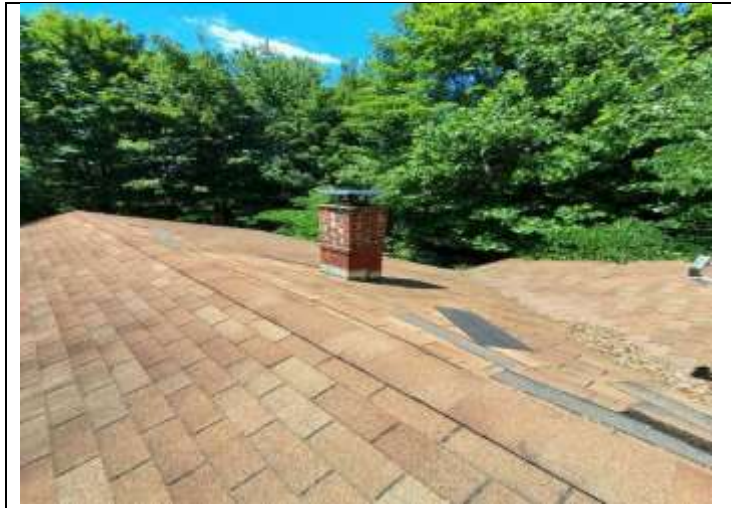
34. View of 475 Beaver Dam Road – ACM Chimney Flashing

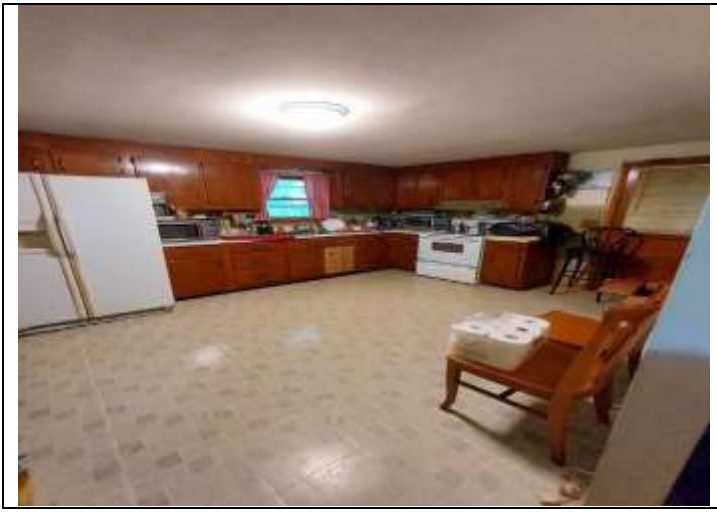
37. View of 475 Beaver Dam Road – ACM Linoleum
