## Morristown's Foote's Pond

## Pond restoration brings community together

Anthony M. DeVizio, PE, PLS/Town Engineer, Town of Morristown; Natalie BeCoats, Communication Specialist/Bergmann PC for Colliers Engineering & Design

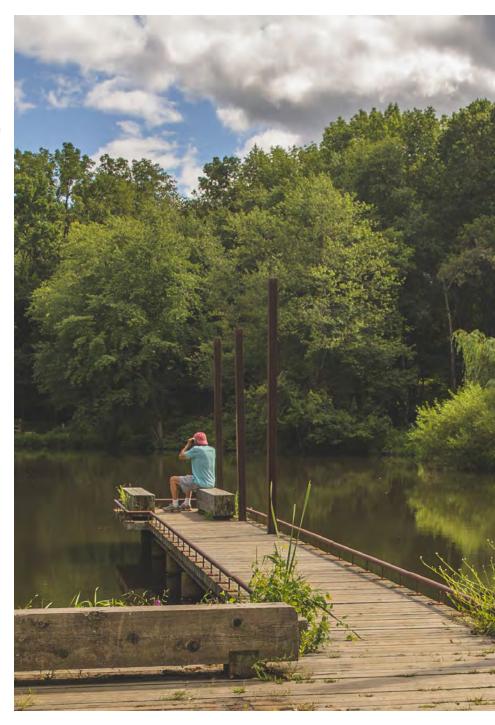
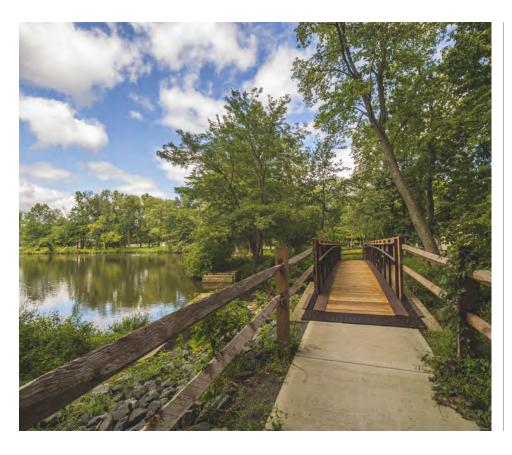
Over 40 years of sediment and vegetative debris settled in the bottom, degrading the pond's health and ability to support wildlife.

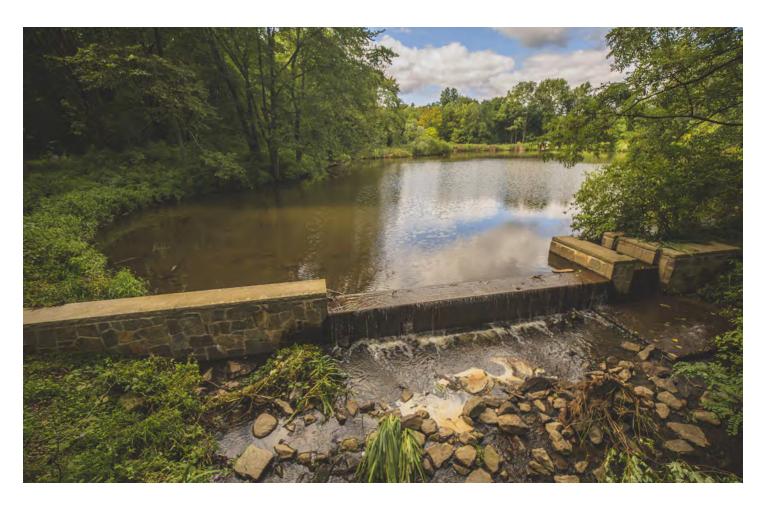
When construction was complete, the hydro-rake had removed around 5,400 cubic yards of organic matter. This brought the water depth to an average of 2.5 to 3 feet, with a maximum depth estimated at 4 feet, marking a significant improvement from its prior state. Before the project, the pond had approximately 58,000 square feet of open water. At project completion, the water surface area had increased to 80,000 square feet. By culling the heavily meadowed areas of the pond, over 35% of additional surface water area was reclaimed.

The hydro-rake is a unique floating excavator equipped with a long hydraulic arm with a rake attachment that combs the pond bottom to remove detritus, vegetative debris, and aquatic vegetation with attached root systems. Hydroraking enables the operator to be more selective in removing only organic material. This method is also a more holistic means of improving the water quality and ecology, causing less disturbance to associated wildlife habitats in and around the pond.
